Project: The Christchurch Gondola
Date: December 2013
Client: Welcome Aboard
Location: Christchurch

Rockfall Bund

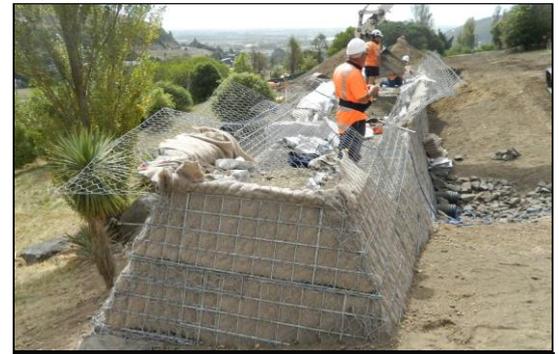
Construction of the Green Terramesh Rockfall Bund

Another mitigation measure utilising the **Green Terramesh (GTM) Bund** was constructed near the base station protecting the car park; location where visitors congregated. This **GTM bund** is 2.4m high by 40m long. The **Green Terramesh Bund** is a reinforced soil structure. These structures are well known for their versatility and great ability to absorb energy especially during the earthquakes.

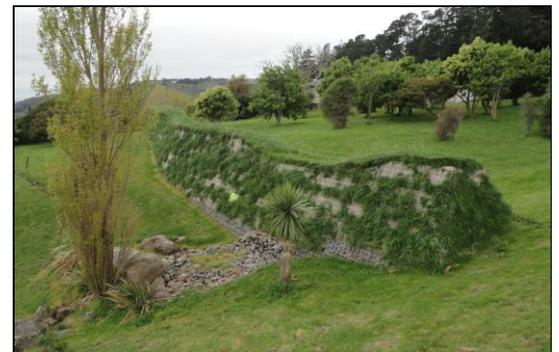
Green Terramesh Rockfall Bund growing greenery

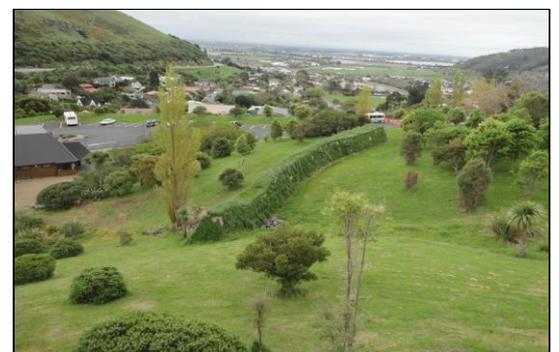
Completed Green Terramesh Rockfall Bund
